## TECHNICAL NOTE #11

### Remedial Practice to Safeguard Face Bricks & Mortar Joints from Sea Spray Attack

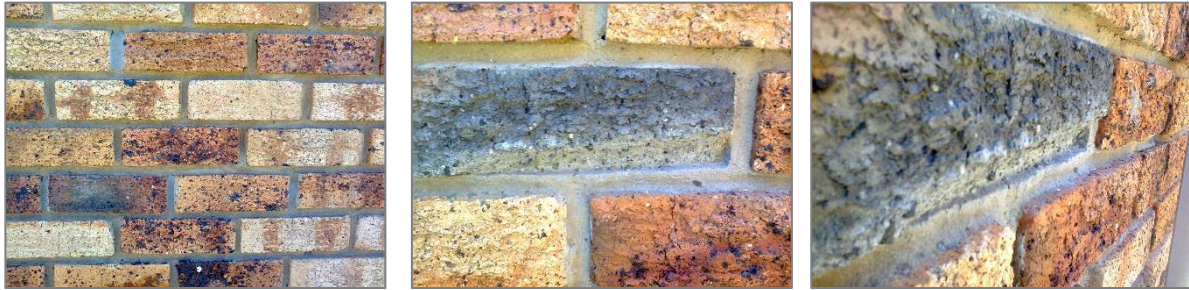
### CASE STUDY 1

The house is 26 years old and to protect these surfaces from the sea climate and prevent possible damp penetration a water based sealant was used, that dries to a slight sheen finish. The owner is concerned that a number of brick are disintegrating?

A water based sealant had been applied to the external face brickwork some years previously. The objective had been to protect the face brickwork from the harshness of the coastal zone weather. The owner was later told that this sealant prevents the walls from "breathing" since it forms a film on the surface, and wanted to know if this sealant is going to cause problems in the future and does it need to be removed.

“Looking at the photos of the brickwork, there is no significant deterioration of the external economic face bricks over the 26 years of exposure to what must be a sea spray zone in a coastal area.

“Overall the quality of the bricks and brickwork workmanship looks good. In my experience any face bricks not exhibiting any signs of flaking/disintegration after 26 years of exposure in a coastal zone are unlikely to fail in the future.

“What the photos show is typical of sodium chloride, sea spray zone attack where the dissolved sodium chloride crystallises ~~out~~ inside the pore structure of the fired clay face brick and progressively breaks down the pore structure just below the surface of the brick due to the salt crystals forming and imposing significant pressures on the pore structure.

“The application of a water-based sealant, whilst not desirable, might in this instance not be a significant factor in the deterioration of individual face bricks. I would recommend that the remedial work of replacing the low number of flaking face bricks be carried out, and observe the face bricks performance over time,

“If there are less than 200 external face bricks affected, I would recommend that a suitably reputable local building contractor be requested to quote on the following:

- Either remove the remaining portion of flaking brick and replace with a matching brick, or cut a suitable brick slip [face brick surface of a matching brick cut to a depth of 20mm] to fit into the volume available.
- Replace with a suitably matched well burnt face brick sourced from a local brick maker or builders merchant.
- Re-point with a 1:3 mortar mix and a well-polished half round joint.

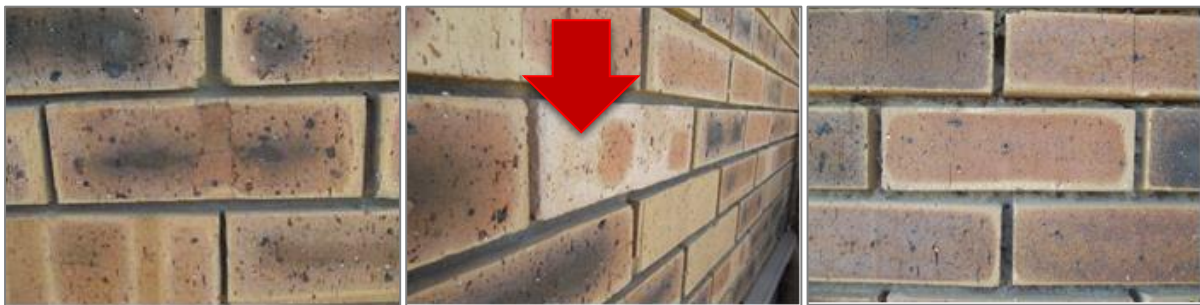
## CASE STUDY 2:

A sea facing house built 15 years ago, some 300 metres from the beach with a SE elevation is situated in the most severe of sea spray zones, Exposure Zone 4. Inspection of the exterior walling showed that the brickwork and mortar joints had mostly performed well considering 15 years of rigorous exposure, taking into account the following surface deterioration experienced:

The extent of surface weathering of the face bricks was estimated at 2-3% which is relatively low considering the extreme sea spray conditions.

The degree of surface spalling caused by consistent salt water exposure was estimated at less than 2 mm. This is considered to be relatively low for 15 years exposure.

Disintegration of the mortar joints and 2-3% incidence of face bricks with surface disintegration is generally confined to the weather and sea facing SE elevation.

1. Providing that the elevations (other than the SE elevation) are visually and aesthetically acceptable, remedial work could be confined to the SE elevation.

2. A suitably well fired clay face brick, that matches up to the colour and texture of the existing face brickwork needs to be identified. See [www.claybrick.org](http://www.claybrick.org) for details of Clay Brick manufacturers in your area.

3. Identify those face bricks with more than 20% surface deterioration, to have the face chiselled back by 25 mm with a 20 mm matching brick slip mortared into place. It is likely that bricks exhibiting less than 20% surface spalling after 15 years will show negligible deterioration in the future. Alternatively, if such bricks are at a window/door reveal or corner, carefully remove the whole brick and mortar and install a replacement brick.

4. All the SE elevation horizontal and vertical square raked joint mortar joints, not suited to Exposure Zone 4, will have to be chiselled/raked back by 20-25 mm and re-pointed to cover the deteriorating joints, so as to avoid a patchy effect on the face brickwork due to the replacement face brick slips. In the event that the mortar joint deterioration appears more extensive than the face brick spalling, it must be attended to.

5. The re-pointing mortar must be a Class 1 mortar, 1 part cement : 4 parts clean, well graded mortar sand.
6. The mortar joint profile must be either a polished weather struck joint or half round well-polished bucket handle profile, so as to create a low porosity joint that minimises future ingress of salt spray, thereby protecting both the joints and face bricks.
